**KOOTENAI DEVELOPMENT IMPOUNDMENT DAM**  
**February 7<sup>th</sup>, 200<sup>8</sup> ROUTINE INSPECTION REPORT**

**BILLMAYER & HAFFERMAN ENGINEERING INC.**

**February 23, 2008**

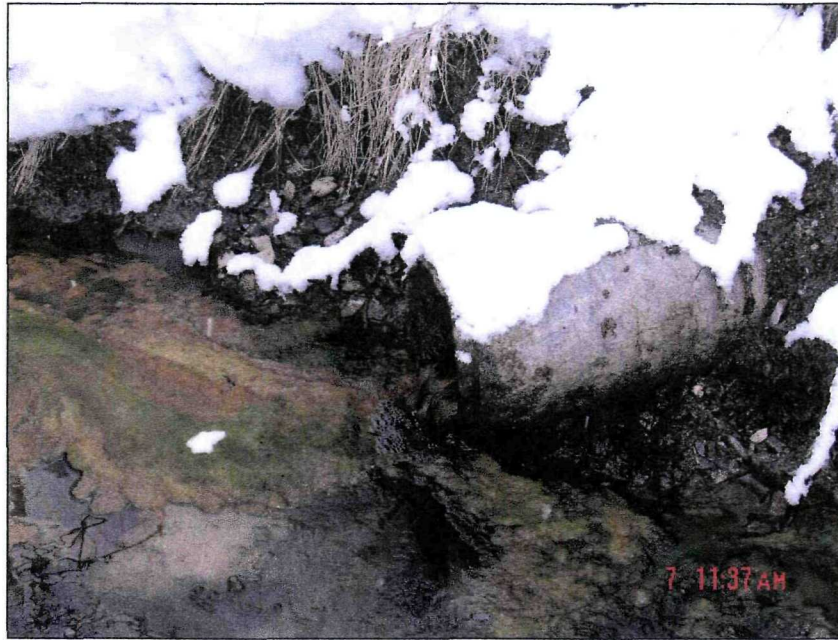
**Figure 1: Drain 4**

Drain 4: An 8-inch concrete pipe, with the bell end sticking out, in the left side, approximately 50 feet from left groin. The drain was flowing water and the flow was clear. The flow amount was typical for this drain. A photograph on the day of the inspection is shown in Figure 1 below;

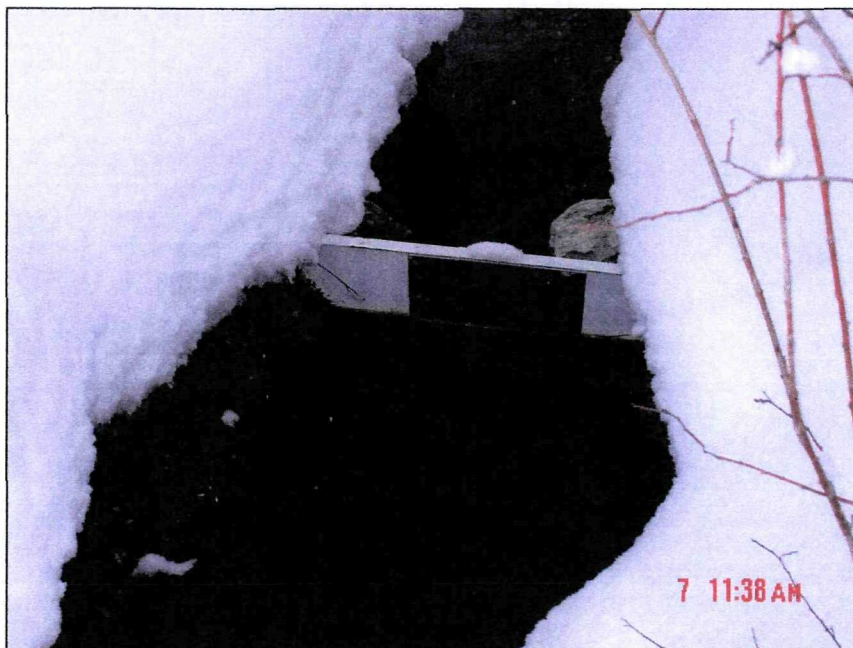
**Figure 2: Weir 1,2,3,4**

The weir below drains 1,2,3,and 4 was checked and the reading was found to be  $\frac{1}{2}$  inch which corresponds to a flow of 12.6 gpm. This is the same reading as the December 26<sup>th</sup> inspection. A photograph of the weir is shown in Figure 2 below;

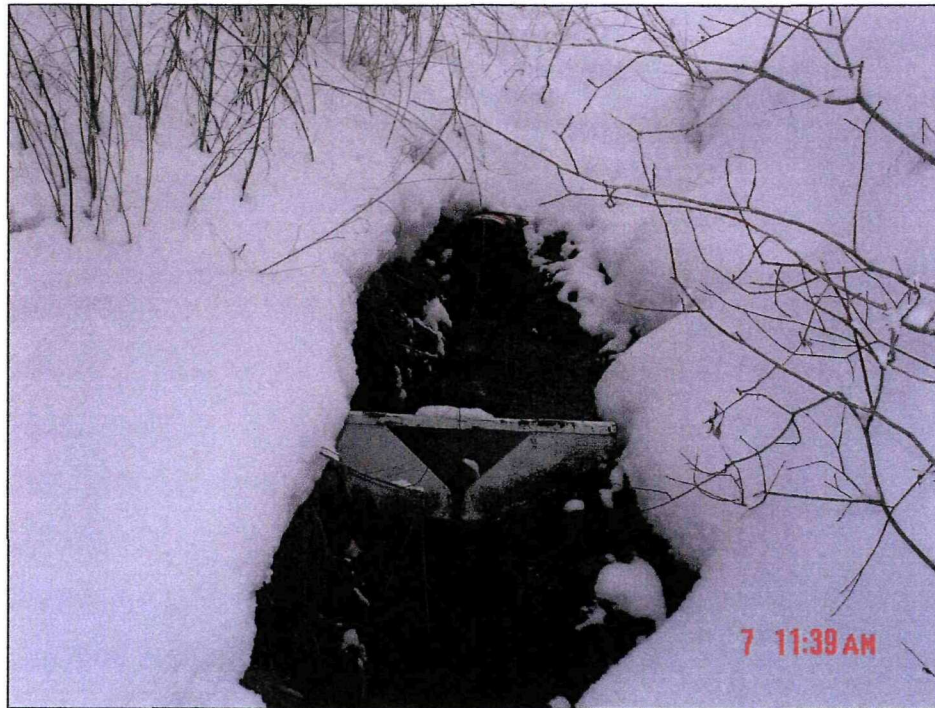
**Figure 3: Drain 5**

Drain 5: Is a corrugated metal pipe near the center of the dam. The drain had a small amount of flow. The amount of flow is typical for this drain. The V-notch weir below this drain was noted as being  $1\text{-}\frac{1}{8}$ <sup>th</sup> inch which is a flow of 3.33 gpm. The

flow in the December 26<sup>th</sup> inspection was 2.35 gpm so the flow was slightly increased. A photograph of this drain is shown in Figure 3 below;

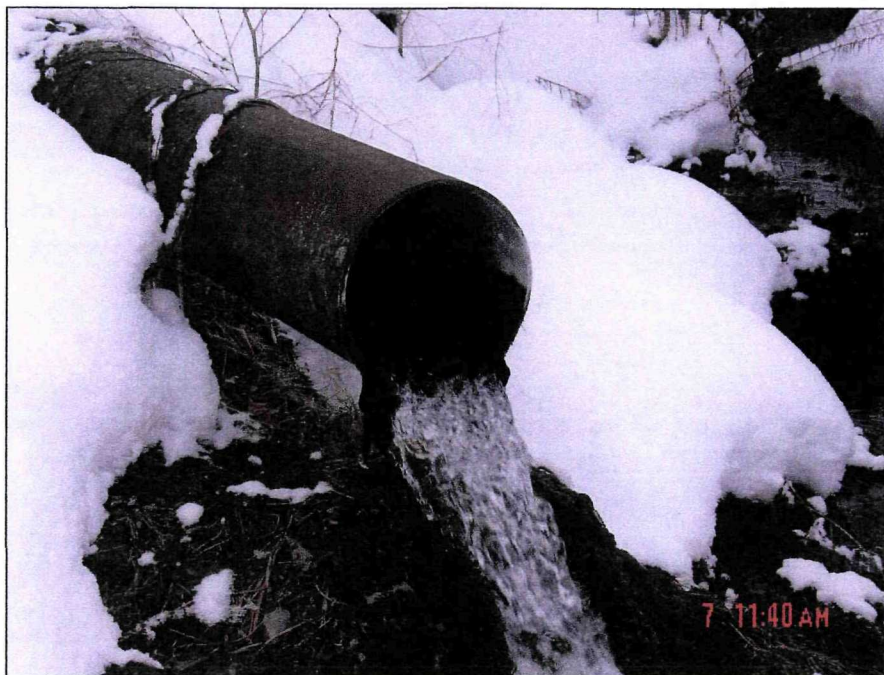
**Figure 4: Drain 6**

Drain 6: Is the large steel pipe in the center of the embankment. The flow was normal. The water depth was noted as being 11-5/8 inches down from the top inside. The December 26<sup>th</sup> measurement was 11-5/8 so this drain flow has not changed. A photograph of the drain is shown in Figure 4 below;

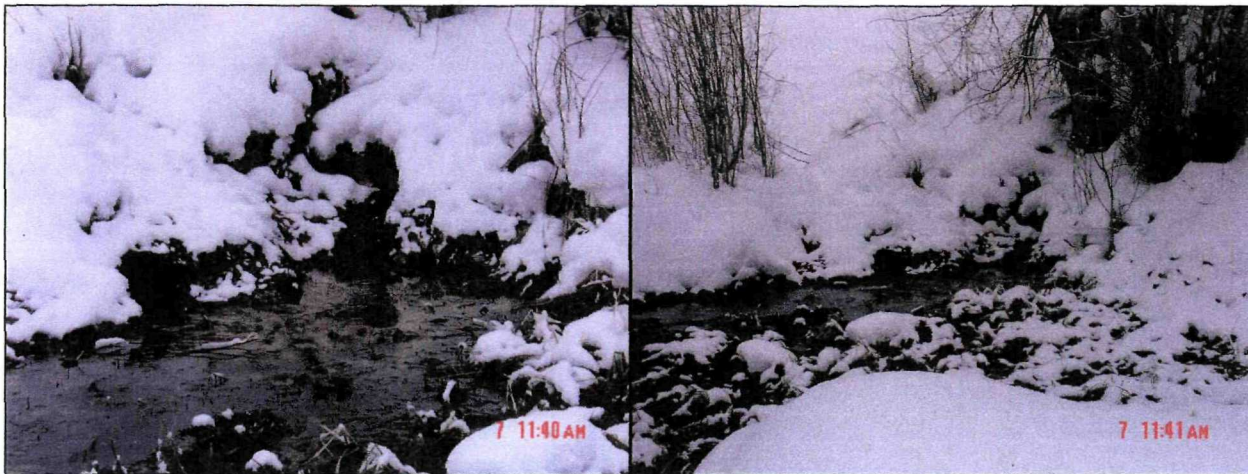
**Figure 5: Area around Drain 8**

All of the drains were flowing at the normal flow rate and no anomalies were found in the drain flow. A photograph of the outside of each drain was made. It was noted that the wet areas below drains 7 and 8 was slightly wider than normal.

Drain 7 and Drain 8: Drains 7 and 8 are located together on the right side of the center of the embankment. Drain 7 is on top of Drain 8. Drain 7 is typically dry and was dry at this time. Drain 8 is an old CMP that is half buried in the silts. Drain 8 had a small amount of flow. It was noted that the area around this drain appeared slightly larger than had been previously observed. It may have been that it appeared larger because of the heavy snow around the other drains. This area will continue to be monitored. Drain 7 was covered with snow and a photograph was not practical. The area around Drain 8 is shown in Figure 5 below.

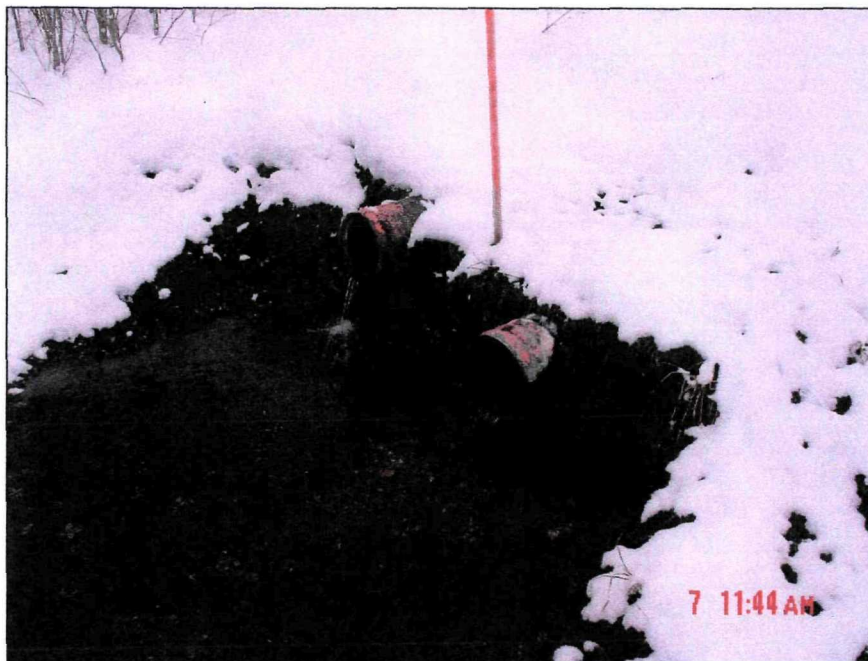
**Figure 6: Drain 9 and Drain 10**

Drain 9 and Drain 10: Drains 9 and 10 are a pair of drains located approximately 100 ft. left of the right groin. Drain 9 is a CMP and Drain 10 is a concrete pipe drain. There was water flowing from both drains which is typical of these drains. The flow is clear. Photographs of the drains are shown in Figure 6 below.

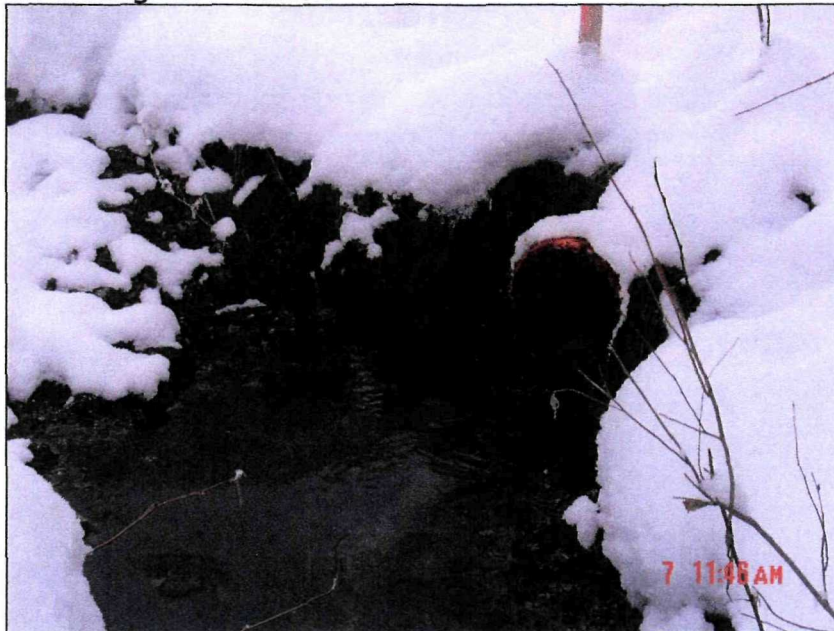
**Figure 7: Drain 11**

Drain 11: Drain 11 is an 8-inch concrete pipe. The drain was flowing water as is typical of this drain. The flow was clear and was a normal amount. A photograph of the drain is shown in Figure 7 below:

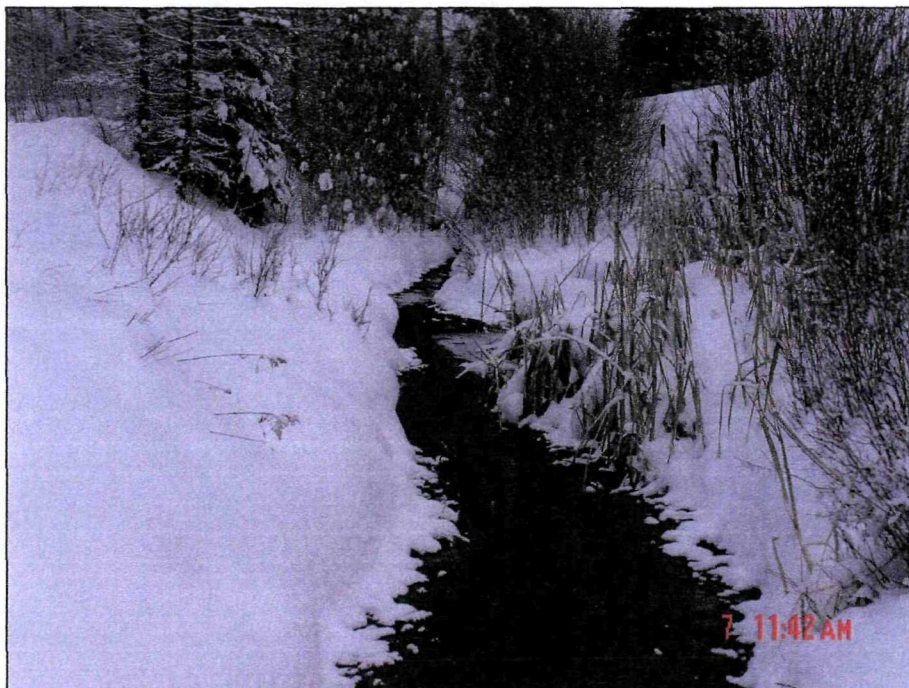
**Figure 8: Stream Channel below Drain 11 and Drain 12**

Drain 12 was covered with snow and a photograph was not practical. The V-notch weir below the drain was read and the reading was 1-3/4 inches which corresponds to a flow of 9.43 gpm. The flow in December was also 9.43 gpm. The stream channel below Drain 11 and Drain 12 had the normal amount of water flow below the drains. The channel is shown in Figure 8 below.

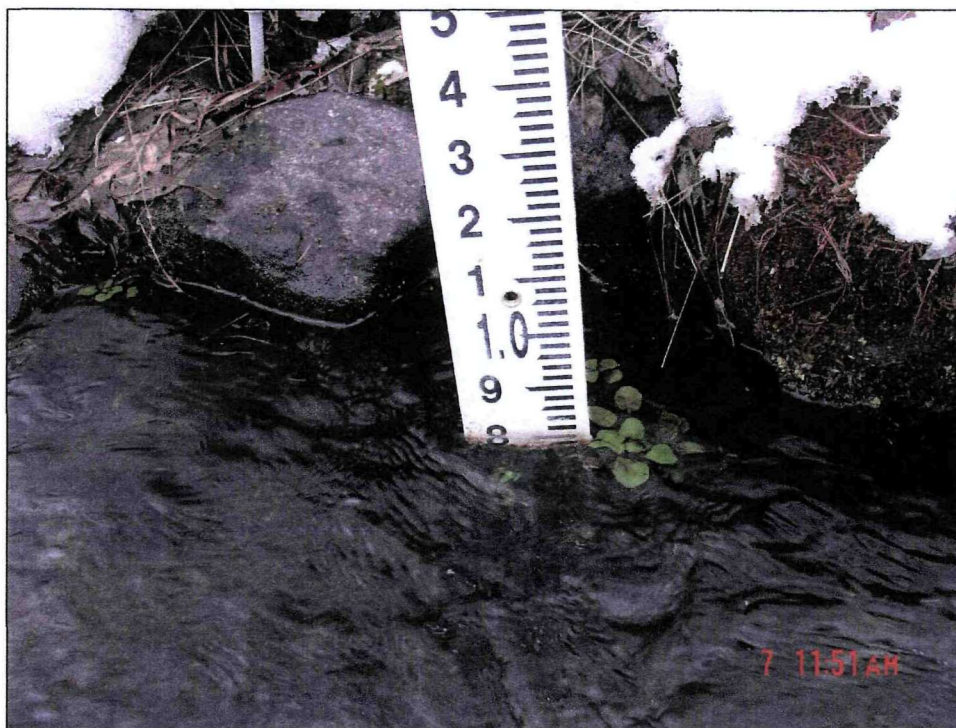
**Figure 9: Stream Gauge**

Main Channel: The staff gauge reading was taken. The staff gauge read 0.80 ft. After the November 9<sup>th</sup>, 2007 inspection the flow measurement data that had been taken the three previous inspections was used to develop a rating table for the staff gauge using FlowMaster®. A copy of the rating table is included in Exhibit 3 to this report. The rating table estimates a staff gauge reading is equal to a flow rate of 0.31 cfs (139 gpm). The flow at the December 26<sup>th</sup> inspection was 0.28 cfs (126 gpm). The flow has increased 13 gpm since the December reading. A photograph of the stream gauge is shown in Figure 9 below.
